TECHNICAL REPORT N-78-1

EXPEDIENT UPGRADING OF EXISTING STRUCTURES FOR FALLOUT PROTECTION

William L. Huff

Weapons Effects Laboratory
U. S. Army Engineer Waterways Experiment Station
P. O. Box 631, Vicksburg, Miss. 39180

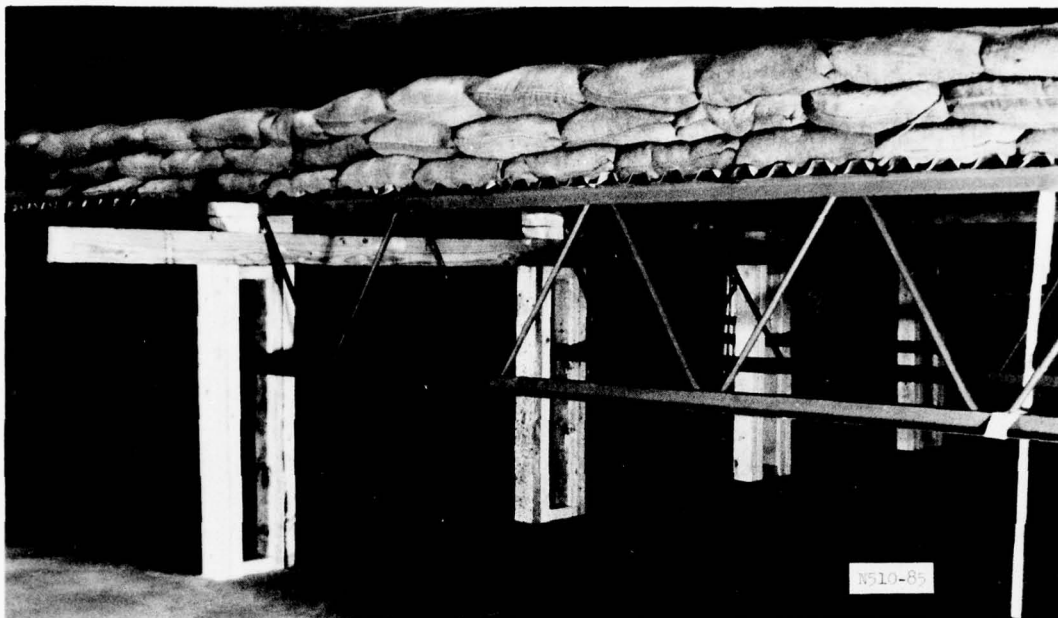
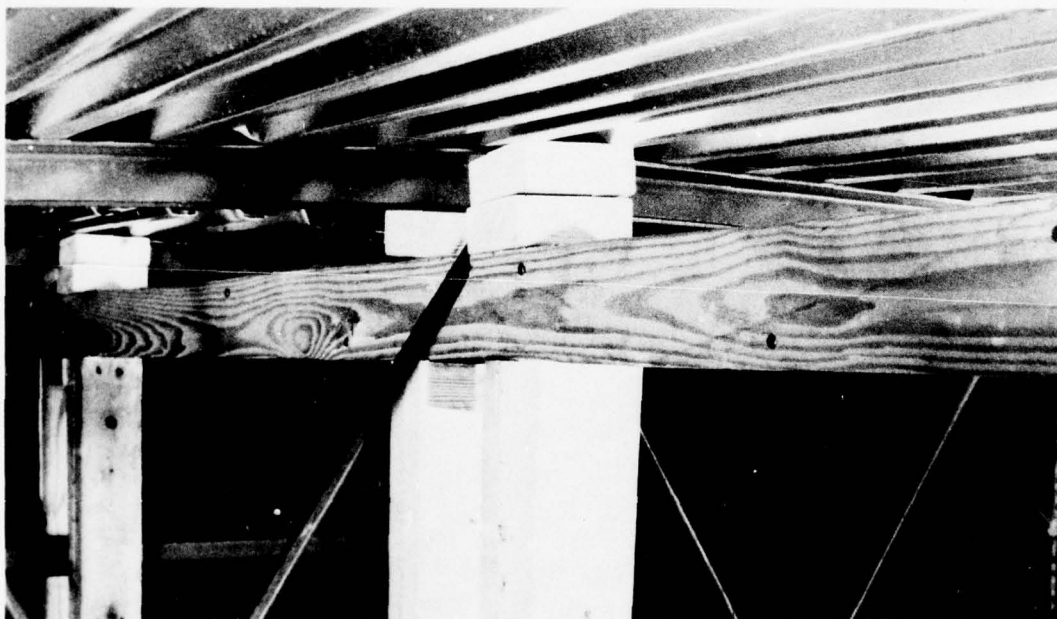
Figure 3.14 Twenty-eight-foot OWJ roof with supports at midspan.

The 28-foot-span OWJ roof system failed at a loading of 16 inches (133 psf) of sand. Added supports at midspan and the one-third points were tested. Midspan supports caused the joist to be overloaded at the supports and are not recommended. The one-third point support system developed allowed the joist to safely support 12 inches of soil along with its design loading. Due to the design of OWJ's, it is imperative that the one-third point support system be attached to the joist as shown in Figure 3.18. An incorrectly attached support system will cause premature failure of the joist. Also, only OWJ roofs covered with metal roof decking should be considered for upgrading and even then upgrading should consist of the addition of a maximum of 12 inches of soil or an equivalent mass of any other upgrading material.

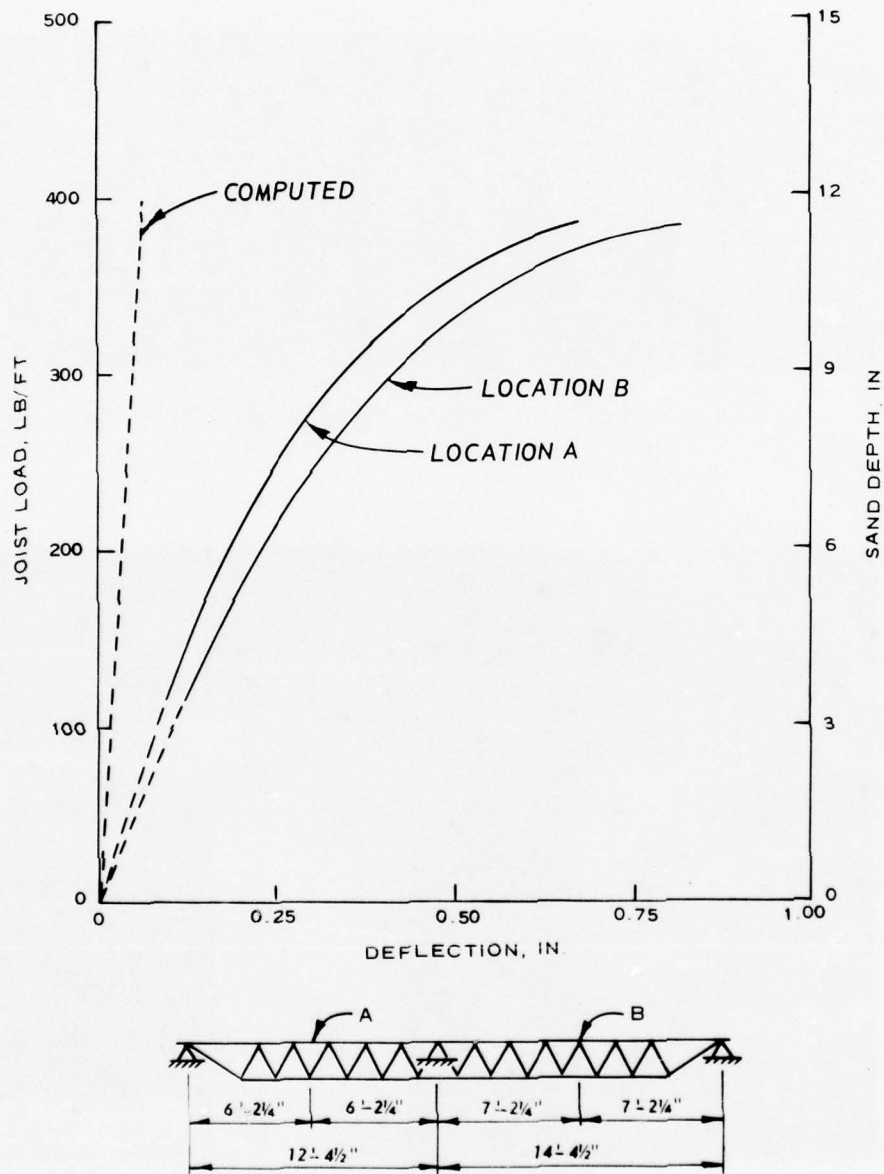
The load-deflection curve for the deflections measured near the quarter points is shown in Figure 3.15. The curves are shown dashed from zero load and deflection to the first point at which measurements were made. The curve is nonlinear from the first measurement indicating that the weld was cracking from the initial loading. The beam and truss analysis predicted the system to be much stiffer than it was. Poor correlation between analysis and test results was due to the failure of the welded joint.

Figure 3.15 Load-deflection curve for 28-foot joist with midspan support.

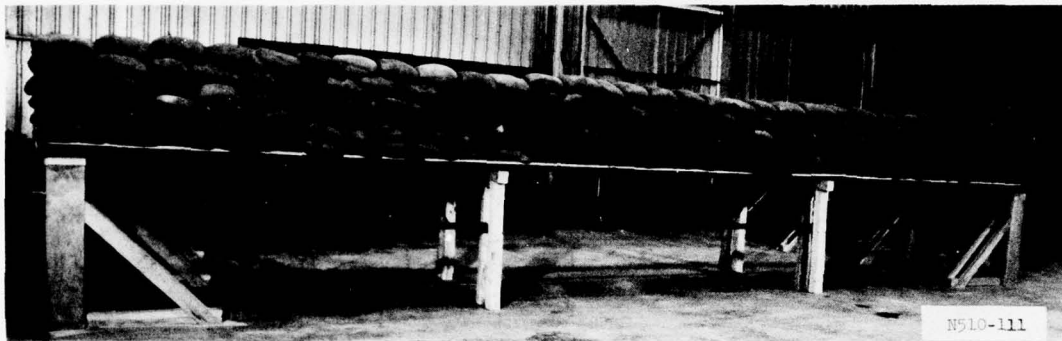
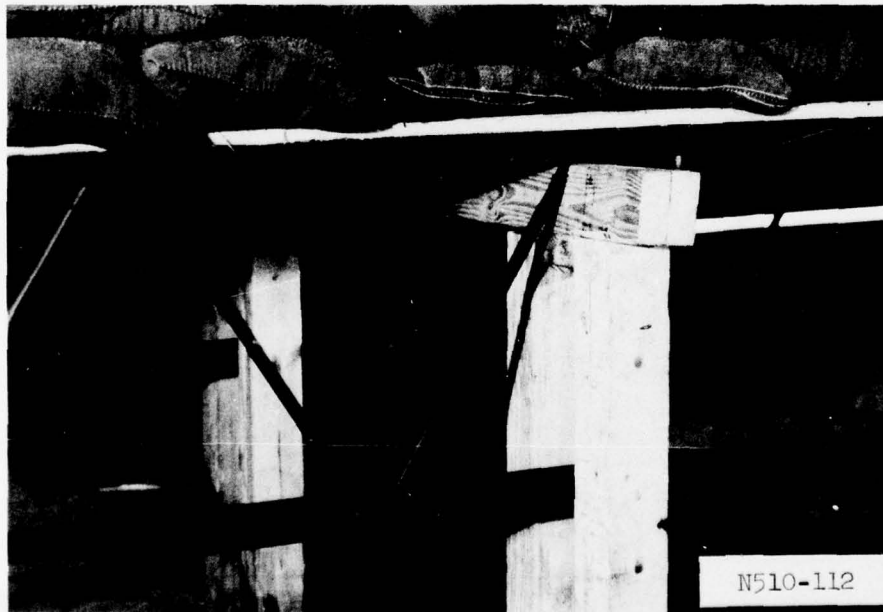
3. End and one-third point supports. Supports were added near the one-third points of the span to reduce the loading from that carried by a midspan support. The two added supports carried 36.7 percent of each of the uniform load on the joist and the end supports each carried 13.3 percent. Moving the support from midspan reduced the load on the support by approximately 43 percent. A mockup of the support system with a 24-inch sand loading is shown in Figure 3.16a. The same 2 by 4 column and beam arrangement used for the midspan support was used for the one-third point supports. However, this time the round bar of the web rested on the 2 by 4 beam rather than supporting the joist by the flanges of the top chord. This relieved the shear on the weld between the top chord and the web bar. Under load the web bar cut into the 2 by 4 beam allowing the joist to deflect slightly at the supports (Figure 3.16b).

The roof system with the one-third point supports carried 24 inches of sand or a loading of approximately 200 psf. The two center joists were carrying a uniform load of 785 plf, which was 2.85 times the allowable uniform load from the joist load tables (Reference 4). The load-deflection curve for the middle joist is shown in Figure 3.17. The joist sat for 12 days with 16 inches of sand on the roof. During that time, the deflection increased approximately 20 percent due to creep. On continued loading the slope of the load-deflection curve increased indicating that the system was stiffer than during the initial loading. The beam and truss analysis again predicted the system to be much stiffer than it was. Crushing of the 2 by 4 support beam under the web members was not considered in the analysis.

Figure 3.16 Twenty-eight-foot OWJ roof with supports at one-third points and a simulated 24-inch sand loading.

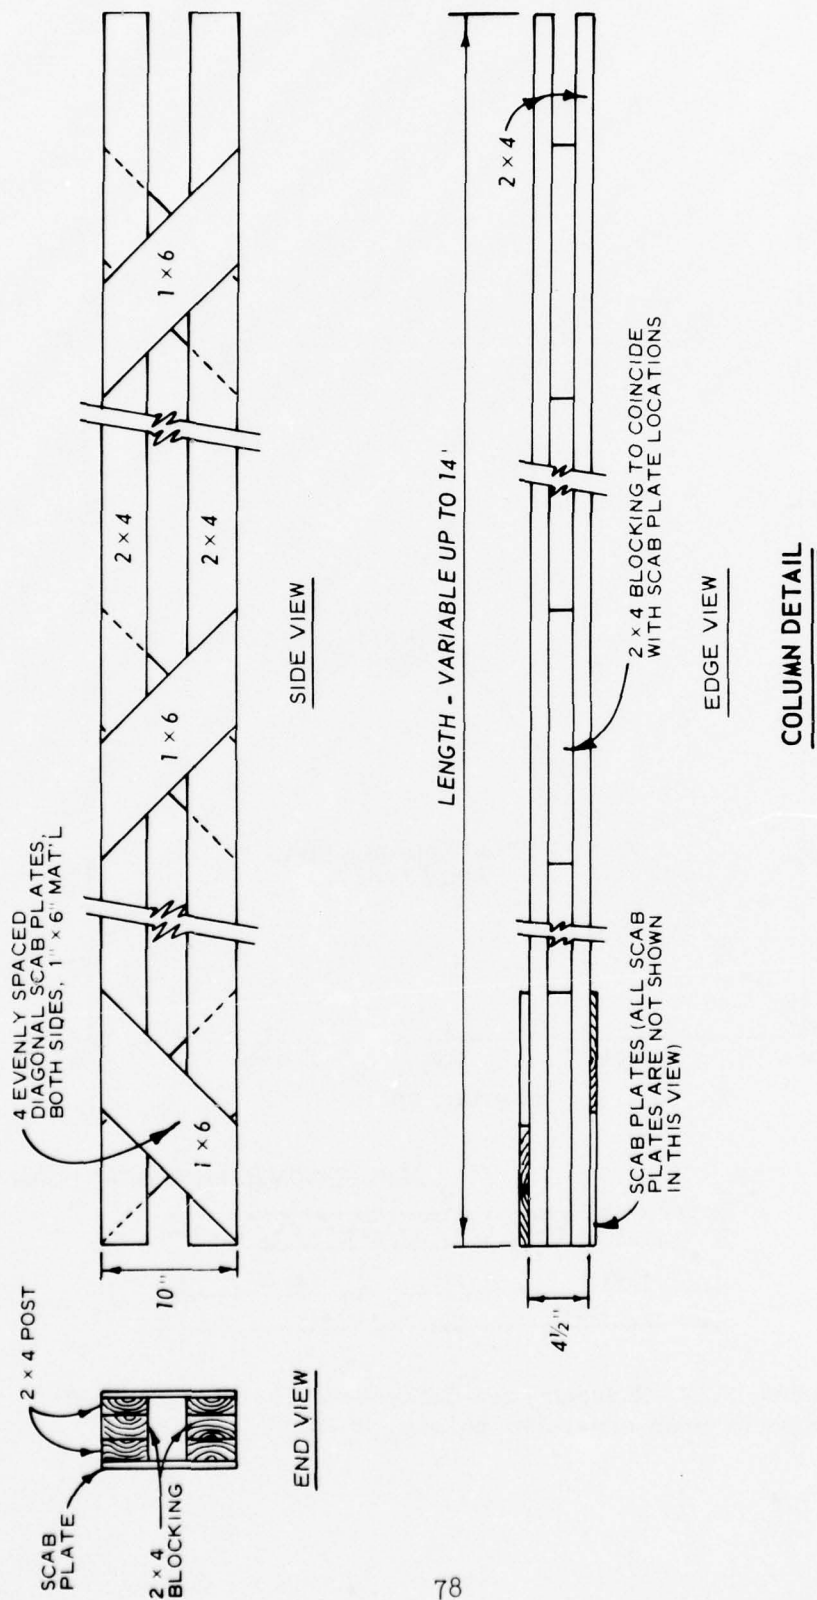
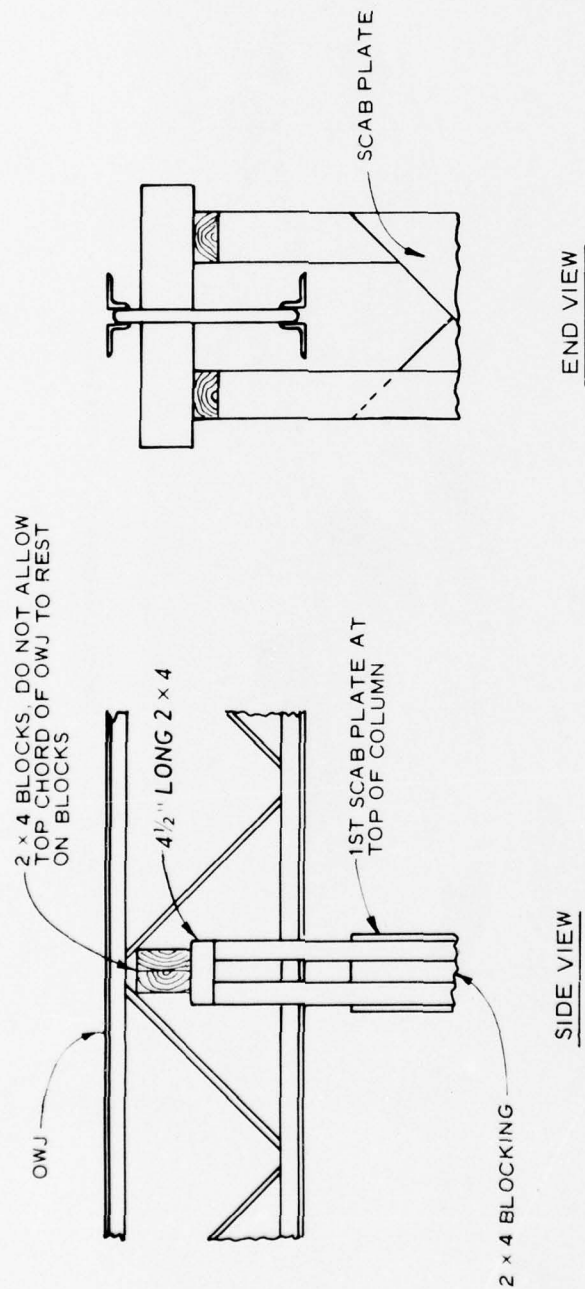
that will safely carry the expected loading is shown in Figure 3.18. Three 1/4-scale models (Figure 3.19) of this column were fabricated and tested in a universal testing machine. The buckling load for the model columns was three times the scaled load that the prototype columns are to support. Columns fabricated as shown in Figure 3.18 can be used as one-third point supports for OWJ roofs having spans of up to 28 feet (the span of the test roof) and covered with 1 foot of soil. The number of columns can be reduced if they are located as shown in Figure 3.20. In this configuration the safety factor against buckling is reduced from 3 to 1.5; therefore, the columns should be braced. The beam spanning between the columns (Figure 3.20) needs to be equivalent to three 2 by 10's.

Figure 3.18 Support column and connection detail for OWJ roofs (sheet 1 of 2).

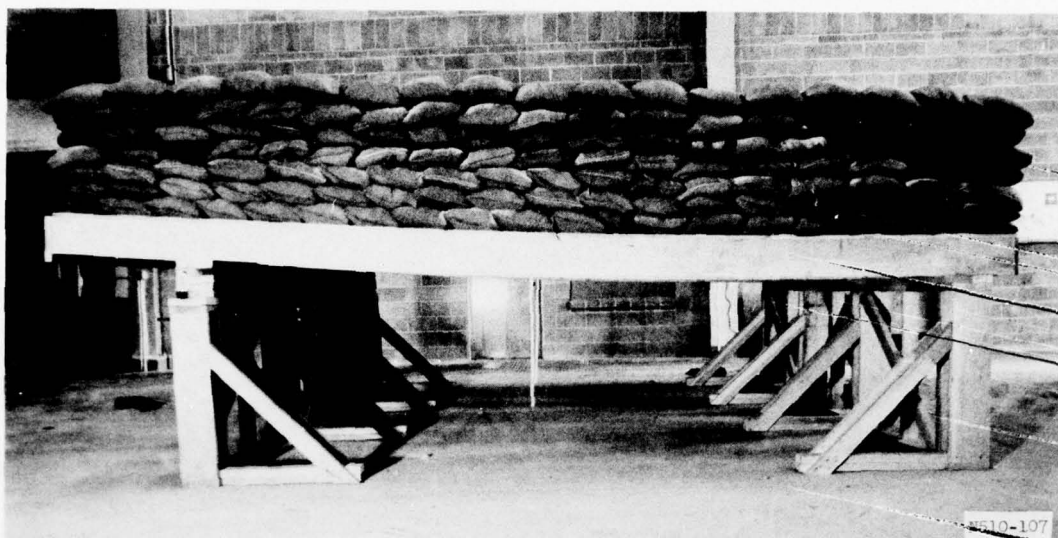
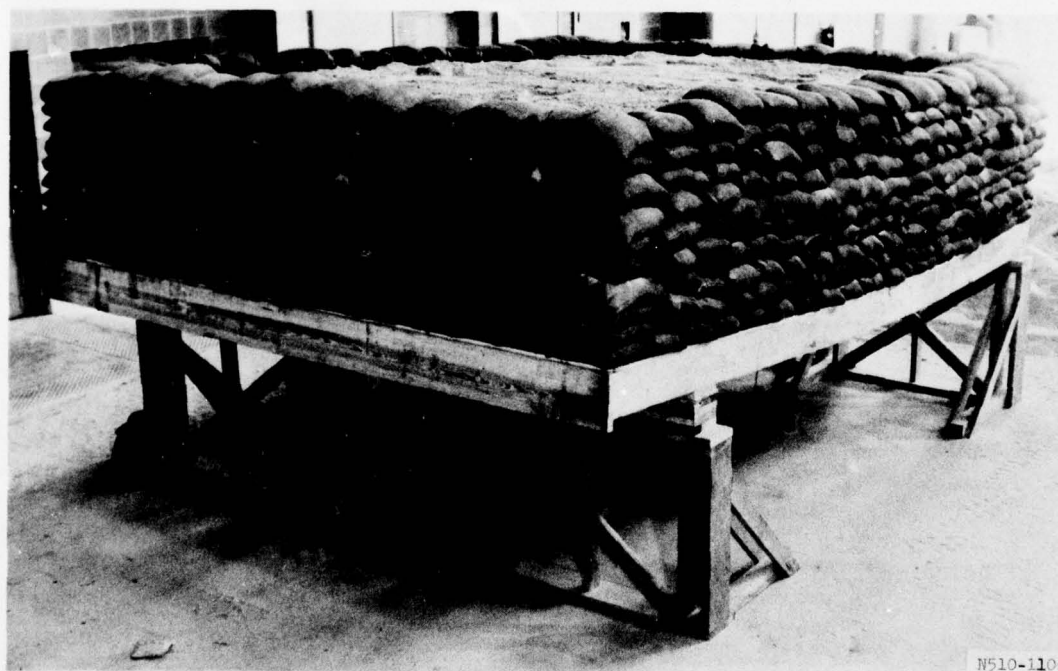
3.2.2 Test Results and Discussion. The wood joist roof is shown in Figure 3.24 supporting 24 and 36 inches of sand (200 and 300 psf). At each of these load levels, the roof was allowed to sit under load for several hours to observe changes in deflections due to creep. The deflection of the joists at midspan increased approximately 3 percent over

Figure 3.24 Sand loading on wood roof system.

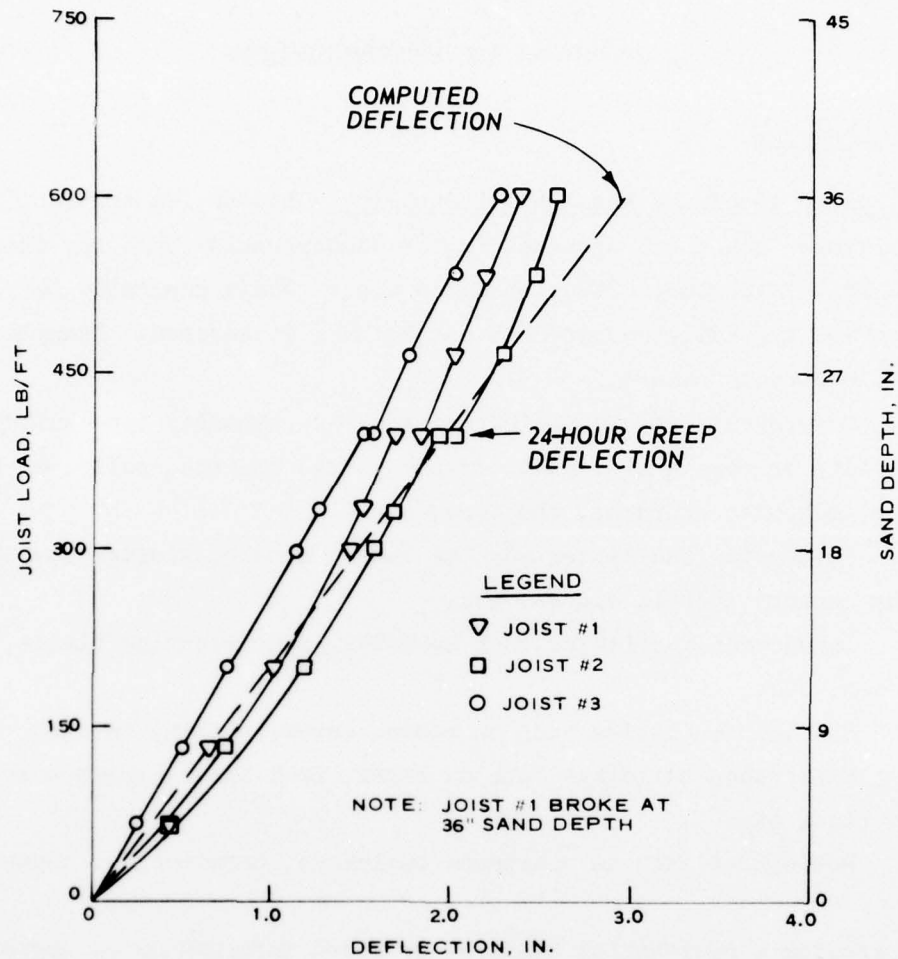
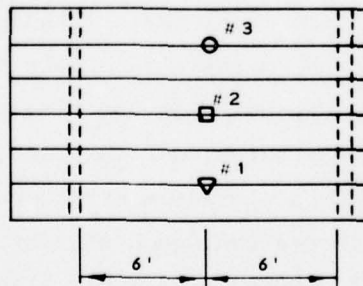
Load-deflection curves for three of the joists for which deflection measurements were reported are shown in Figure 3.27. The surveyor's level used to measure deflections of the joists was moved after recording the deflections with 36 inches of sand on the roof. Therefore, no deflection measurements were recorded after the joist failure. The roof appeared to deflect considerably when the joist broke; however, none of the remaining joists showed any signs of failure after sitting under load for several more hours. The roof system was stiffer than predicted by the computed load-deflection curve, which could be due either to the modulus of elasticity of the fir joist being around 2,000,000 psi rather than the 1,760,000 psi given in handbooks or composite action being developed between the plywood decking and the joist. The stiffness of the roof system assuming composite action between the joist and the decking is twice that of the actual roof system. Therefore, if composite action did develop it was only to a small degree. These results are similar to those presented in Reference 5 where 14-foot-span wood joist floor sections were tested.

Figure 3.27 Midspan load-deflection curve for wood joist roof system.
